Rate problem investigation

Joana Wirth & Rafał Lalik for SCAT

April 09, 2014

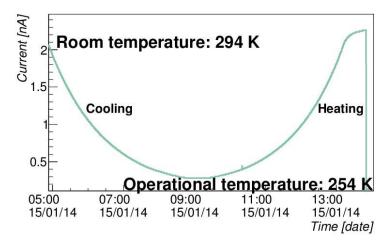
NE5 detector

\rightarrow no leakage current/voltage curve before mounting in NE5 due to leak problem...

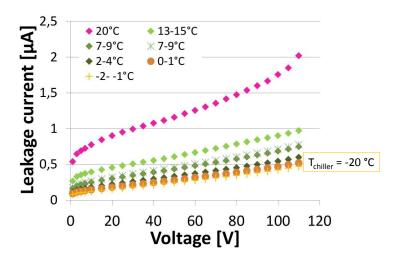
HADES detector

Kindersarg/Prototype

- 20 °C: leakage current ≈ 2 μA
- -20°C: leakage current ≈ 0.5 μA

Final system

- 20 °C: leakage current ≈ 2.5 μA
- -20°C: leakage current $\approx 1 \ \mu A$

Further check needed...

- After bathing no curve was written down? (after 15.11, end of Nov, beginning of Dec)
- Check data between 6.-12.1
