Rate problem investigation

Joana Wirth & Rafał Lalik for SCAT

April 09, 2014

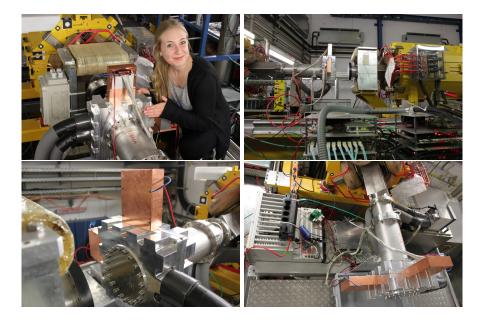
- Detector assembled in final position
- ▶ Pipe vacuum (Friday evening): 1.16 × 10⁻⁷ mbar
- Cooling on at -20 °C (chiller set point)
- Bias on at 160 V with 1.014 µA leakage current
- Noise rate: 100 hits/s to 2000 hits/s
- TRB3 included in TrbNet, DAQ tested
