Pion tracker cooling

Leakage current

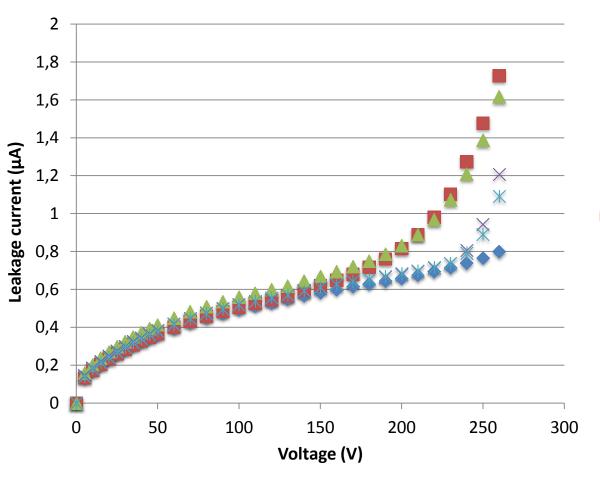
- Before cooling attached
- Cooling device attached
- ▲ Cooling device removed
- imes Channels at the edge are neglected
- **X** 4 Channels in the middle

Depletion voltage: 250 V
